**An investigation into the maintenance of a third
generation artificial rugby surface**

**School of Applied Sciences
Centre for Sports Surface Technology**

**MSc by Research
Academic Year 2012/2013**

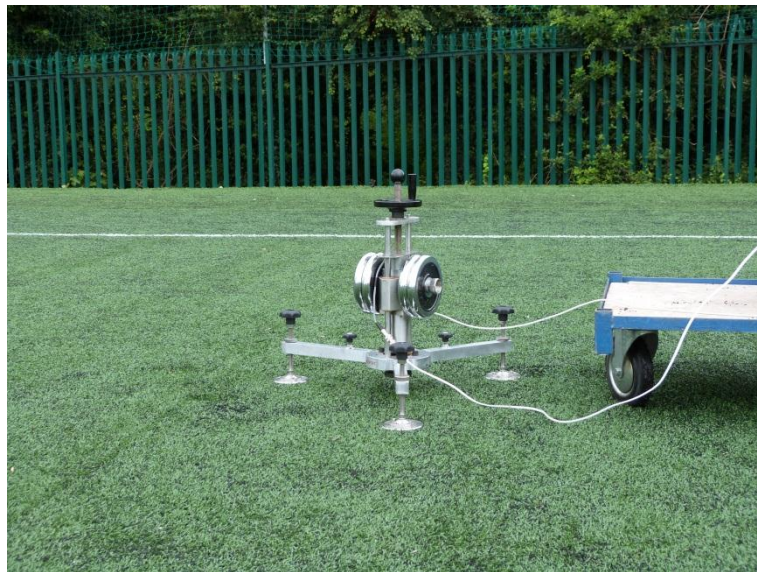
At present the impact absorption properties are measured with the Artificial Athlete (AA) device. The AA measures peak impact force from a controlled energy spring damped impact, allowing force reduction (shock absorption) to be determined. The spring can also be adapted to measure vertical deformation of a surface (Fleming, 2011). Fleming (2011) explains the mechanics of the AA in detail and that the device is considered the gold standard for surface testing across many sports. However, the equipment is very expensive (up to £20,000) and McLeod (2008) highlights difficulties with setting up in the field and portability.

Figure 3.1 The Artificial Athlete

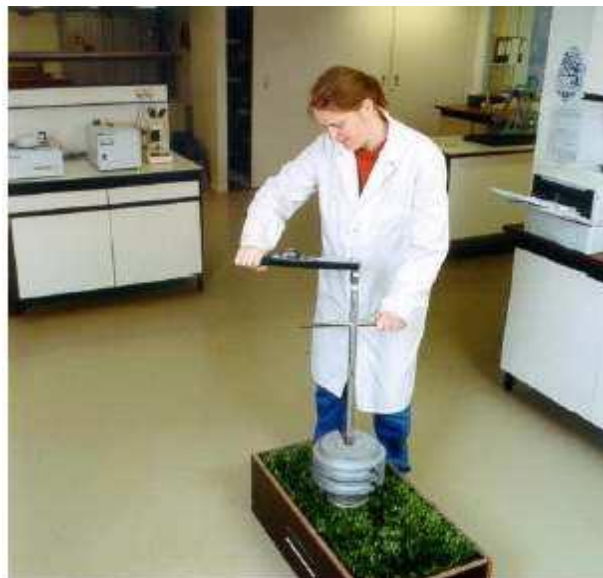
The FIFA and IRB test method for rotational traction uses a Torque wrench and measures the amount of torque necessary to start the motion of a studded sole weighted with a total mass of 46 kg (IRB, 2004). Despite the limitations of this test method, very little exists that could serve as alternative apparatus. Indeed, the Torque wrench apparatus is described as portable, repeatable and useful for indexing or classifying sports surfaces (Severn, 2010).

Figure 3.2 Weighted Torque wrench apparatus. (Source, IRB Performance Spec 2009)

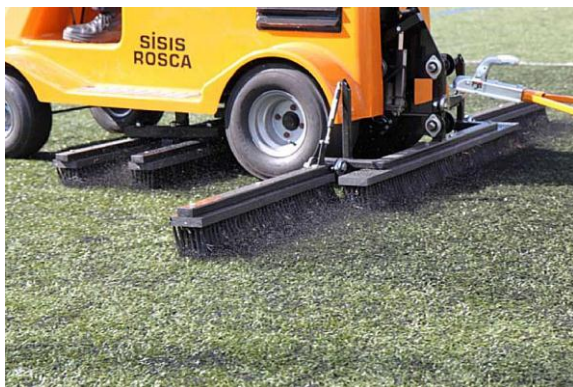
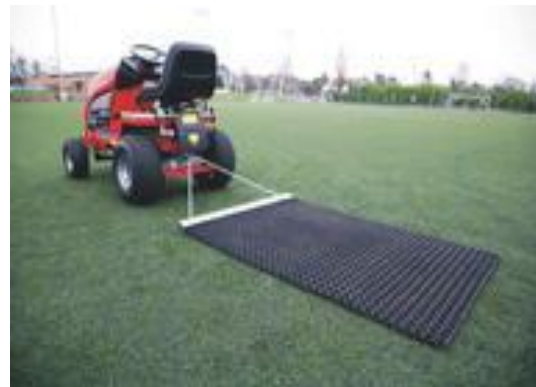
Of these regular tasks, brushing and or drag matting of the surface are considered most important. Cross-brushing is claimed to be the most effective way to keep the surface in top playing condition (Support in Sport, 2008). It is reported the action helps to re-distribute rubber infill from high to low concentration areas. The infill is also agitated from this process, helping to remove contaminant particles and fibre fragments to the surface where they can be blown away. The process also claims to ensure fibres are in the correct orientation, preventing them from lying flat.

Figure 3.5 Example of a Drag Brush and Drag Mat used in routine maintenance of a 3G pitch (Source, www.sisis.com, www.technicalsurfaces.com, 2012).

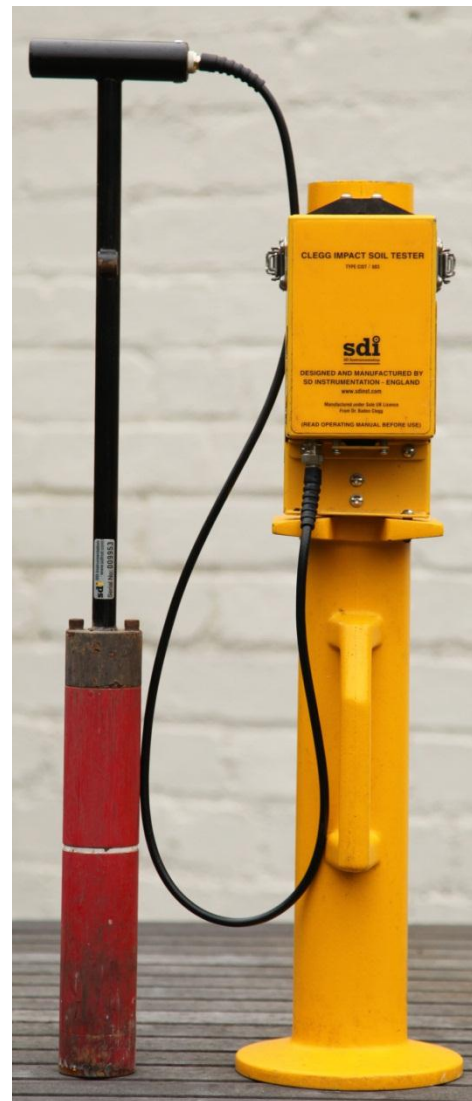
Using the Clegg Hammer with the 2.25 kg weight, each measurement was taken by dropping the weight down the guide tube from a height indicated by the white line mark. Standard operating procedure for this apparatus requires three drops to be carried out on the same point of a surface before a measurement of surface hardness in Gravities is taken. The third drop indicates the value to be recorded. At each survey visit, three repetitions of this process were carried out at each designated testing area. The results were recorded manually.

Figure 4.2 Clegg Hammer

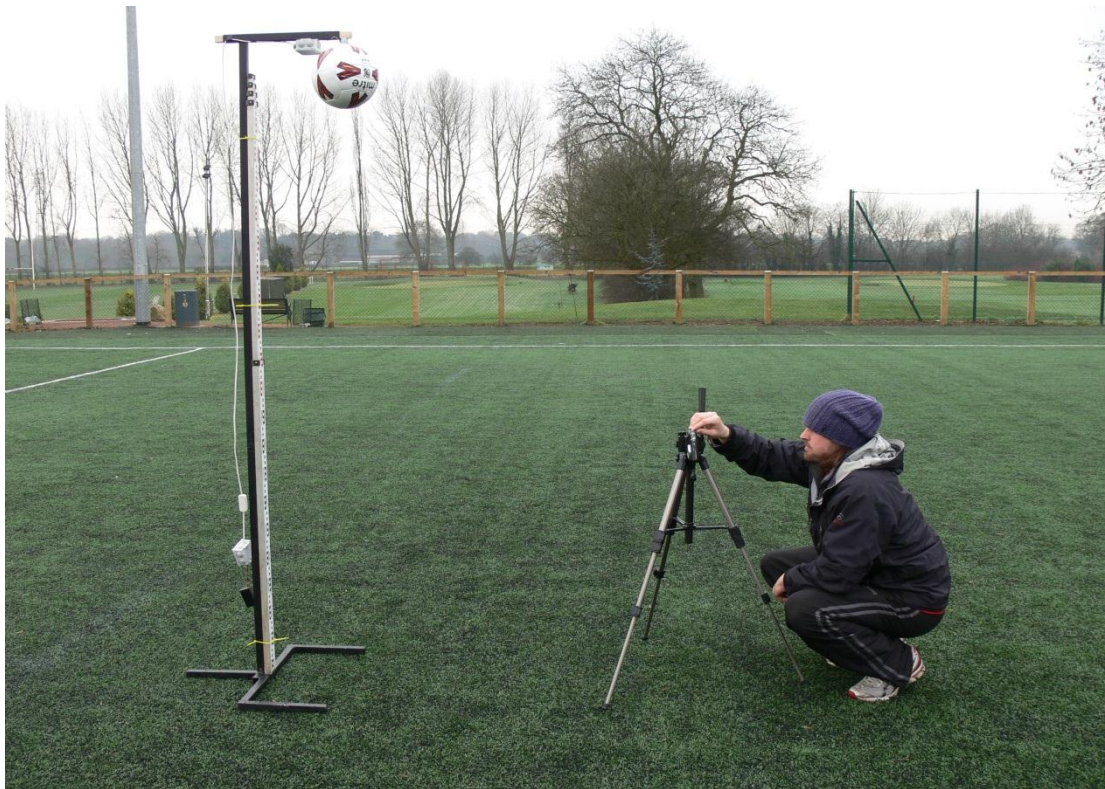
To monitor this parameter, the video analysis method described in BS EN12235 has been used. With a custom built framework and small electromagnet, a ball (FIFA Approved) was suspended two meters from the floor and released towards the ground (see Figure 4.3). The rebound motion was captured on a high definition video camera and the results recorded for analysis. The video data was played back in windows live movie maker version 2011. This software allowed the videos to be advanced frame by frame, meaning the peak rebound height could be pinpointed and measured against a scale attached to the framework. At each test location three repetitions were undertaken.

Figure 4.3 Apparatus used to measure vertical ball rebound

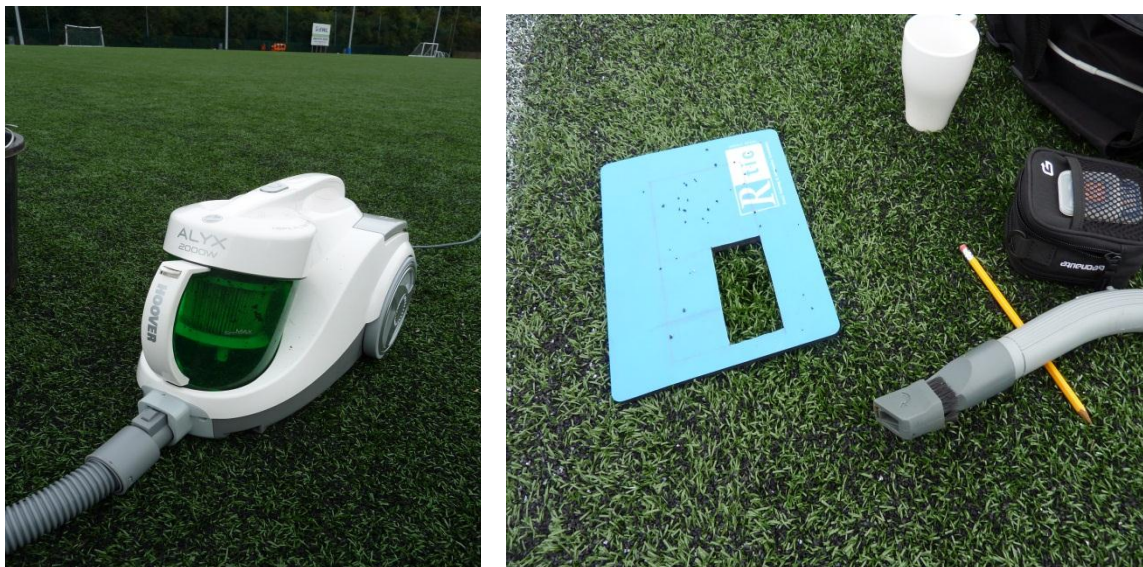
The extraction process was carried out using a 2000 W Alyx mini hoover, mains electrical supply, extension cables, fabricated template, polythene bags and other ancillary tools. Extension cables allowed the hoover to be powered from the club house. In all, four extension reels were required to reach the furthest test point from power source. At each test location, a template (50 mm x 100 mm) was placed on the pitch surface. The infill within the template was first agitated using a pencil and then extracted with the hoover, using the hose extension and the brush attachment. The brush attachment aided in loosening the lower layers of infill allowing the material to be extracted all the way to the carpet backing. Even though there had been a 'dry' period of weather prior to testing, moisture was still present in the infill resulting in the hoover basket having to be cleaned after each sample. Extracted infill was replenished with virgin material of the same specification and packed down with fingertips to ensure consolidation with the rest of the profile. Each sample was bagged and labelled for laboratory analysis.

Figure 4.4 Equipment and ancillary tools used to extract infill from the pitch.

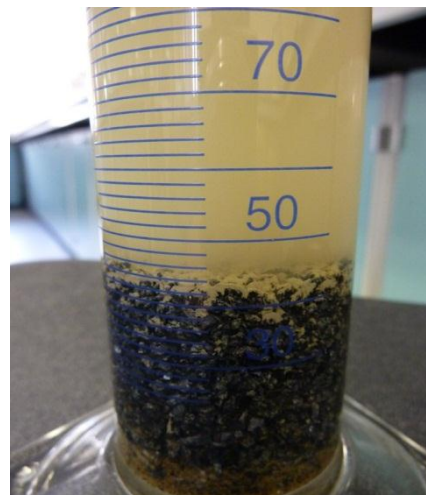
After a 24 hour rest period the cylinders were analysed for contamination levels (Figure 4.5). Due to the relatively small particle sizes of the contamination present (silt $2\text{ }\mu\text{m}$ – $60\text{ }\mu\text{m}$, clay $<2\text{ }\mu\text{m}$) and by comparison, the relatively large particle sizes in the rubber infill layer (0.8 mm - 2.5 mm) the contaminated layer was able to settle over the top of the rubber layer but also migrate into the void spaces left between the rubber particles. Therefore, a number of measurements around each cylinder were taken. Using a ruler in a vertical position, four readings of contamination depth (layer on top of the infill sample) were performed. The results for each sample have been expressed as the average of these measurements.

Figure 4.5 Laboratory testing on infill samples. Contamination is present on top of the rubber infill layer in each sample

congealed and clumped rubber particles together. The paint residue was still present in the sample after laboratory analysis (Figure 4.5, Methodology). This indicates that the paint, although labelled as water soluble, does not break down easily in water. It is suggested that this would reduce infiltration rate from blocking the pore spaces in the infill. A reduction in infiltration rate has been shown to adversely affect playing performance characteristics for both 2G and 3G samples (McLeod and James, 2007). Figure 5.19 shows the effect on infiltration rate when contamination was added to the sand component of the infill on two carpet systems under laboratory conditions.
